U.S. Department  
of Transportation

National Highway  
Traffic Safety  
Administration

Case Vehicle (A): 1999 Volkswagen  
Type: Jetta, 4-door sedan  
Driver: 32-year-old male  
CDC: 06-BDEW-7, 01-FDEW-3

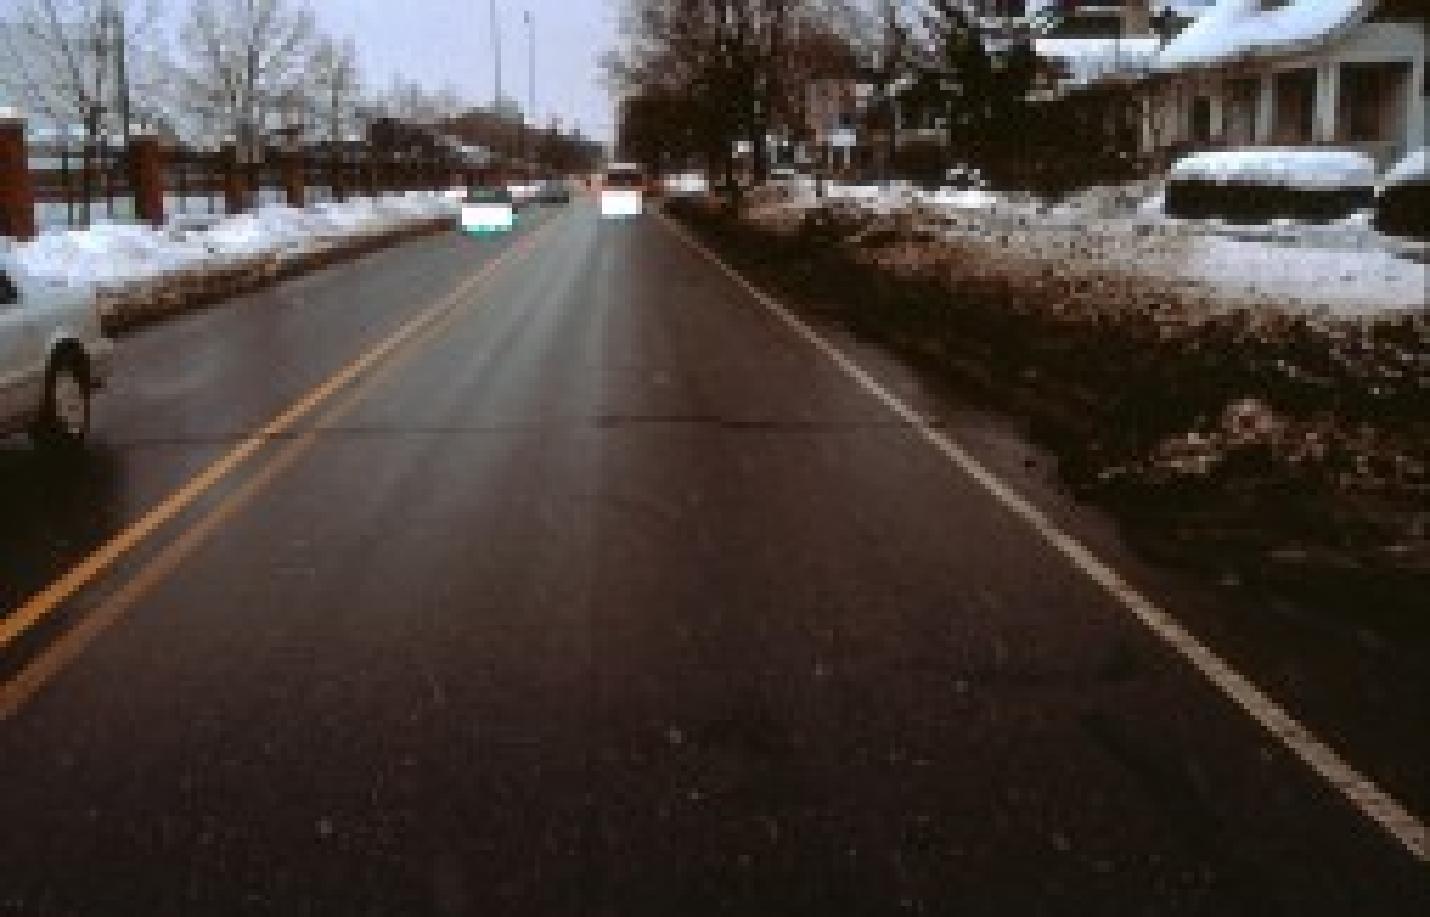
PN22700#1

(Slide 1) Case vehicle (A) was traveling north in the northbound lane of a straight section of a dry, asphalt, two-lane roadway, (slide 2) with a speed limit of 48 kph (30 mph). Vehicle (B) was traveling south in the southbound lane of the same roadway. Vehicle (C) was traveling north in the same northbound lane, behind case vehicle (A). Vehicle (C) struck the rear of case vehicle (A) and caused case vehicle (A) to veer sharply to the left, cross the centerline, and enter the path of vehicle (B). The driver of case vehicle (A) reportedly attempted to avoid a collision with vehicle (B) by veering to the right and braking, but case vehicle (A) struck the front of vehicle (B) with its front.

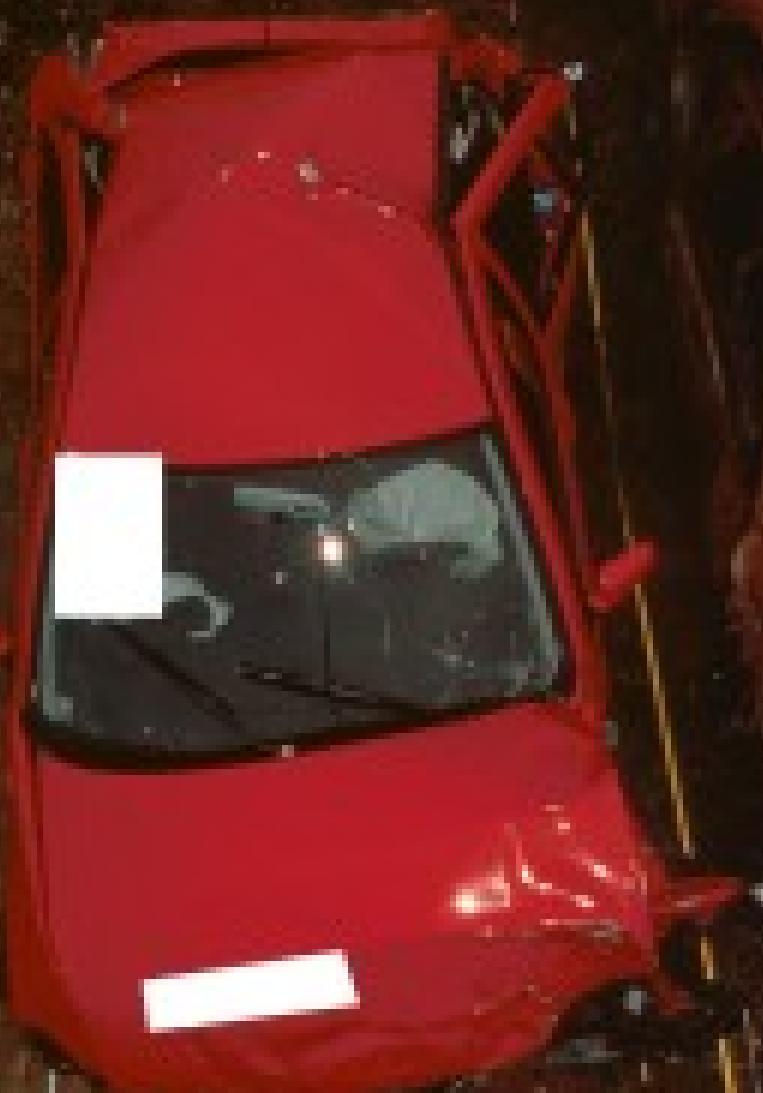
PN 22700 #3

(Slide 3) Damage to case vehicle (A) was severe. The direct-damage length for the rear impact was 151 cm and extended across the entire rear of the vehicle. The maximum crush was 91 cm and occurred 28-cm inboard from the left-front bumper corner. The direct-damage length for the frontal impact was 152 cm, and extended across the entire front of the vehicle. The maximum crush was 45 cm and occurred 56-cm inboard from the left-front bumper corner. The left wheelbase was reduced 16 cm, and the right wheelbase was reduced 8 cm.

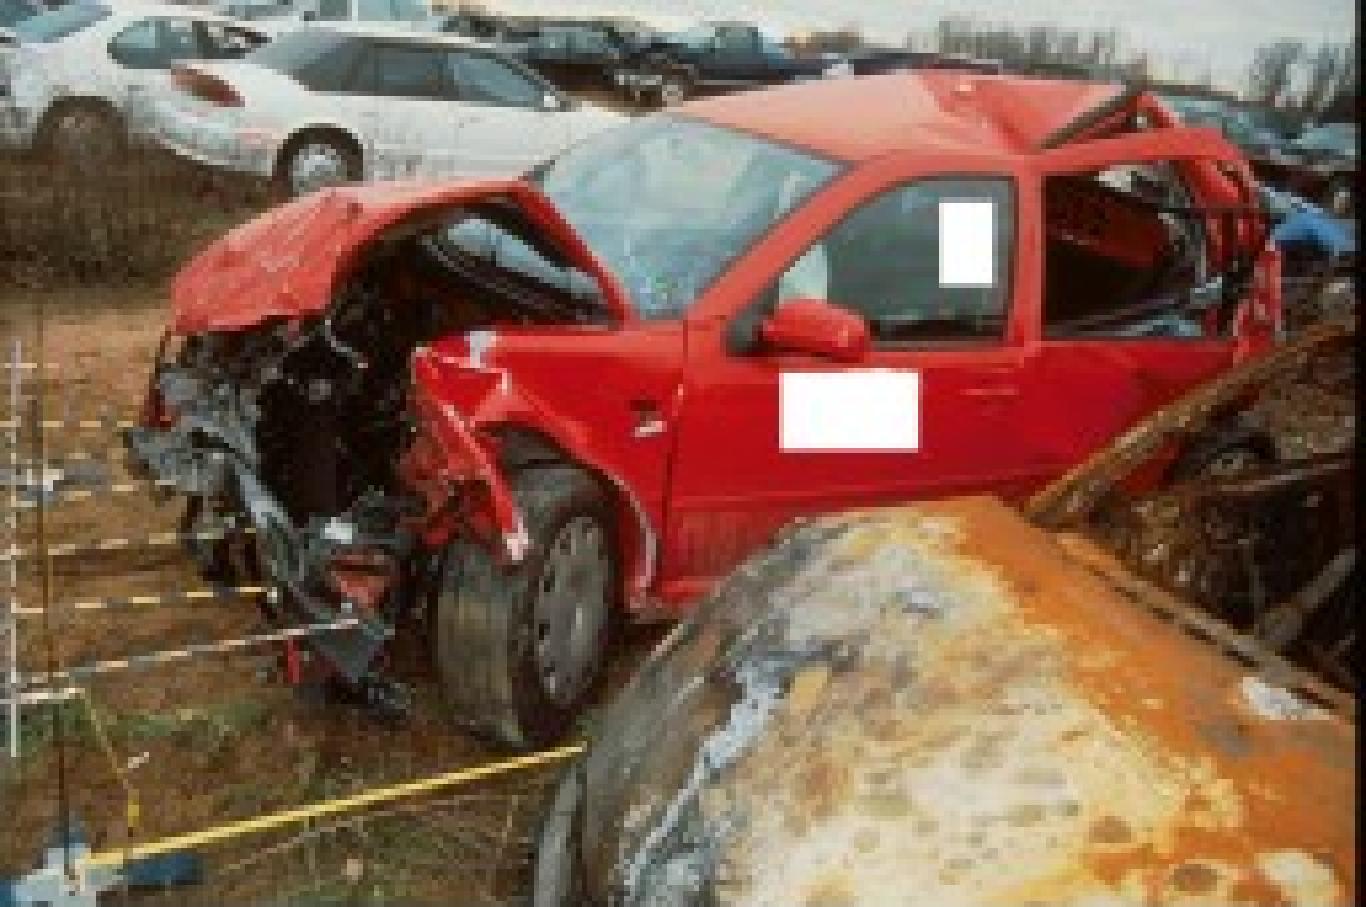
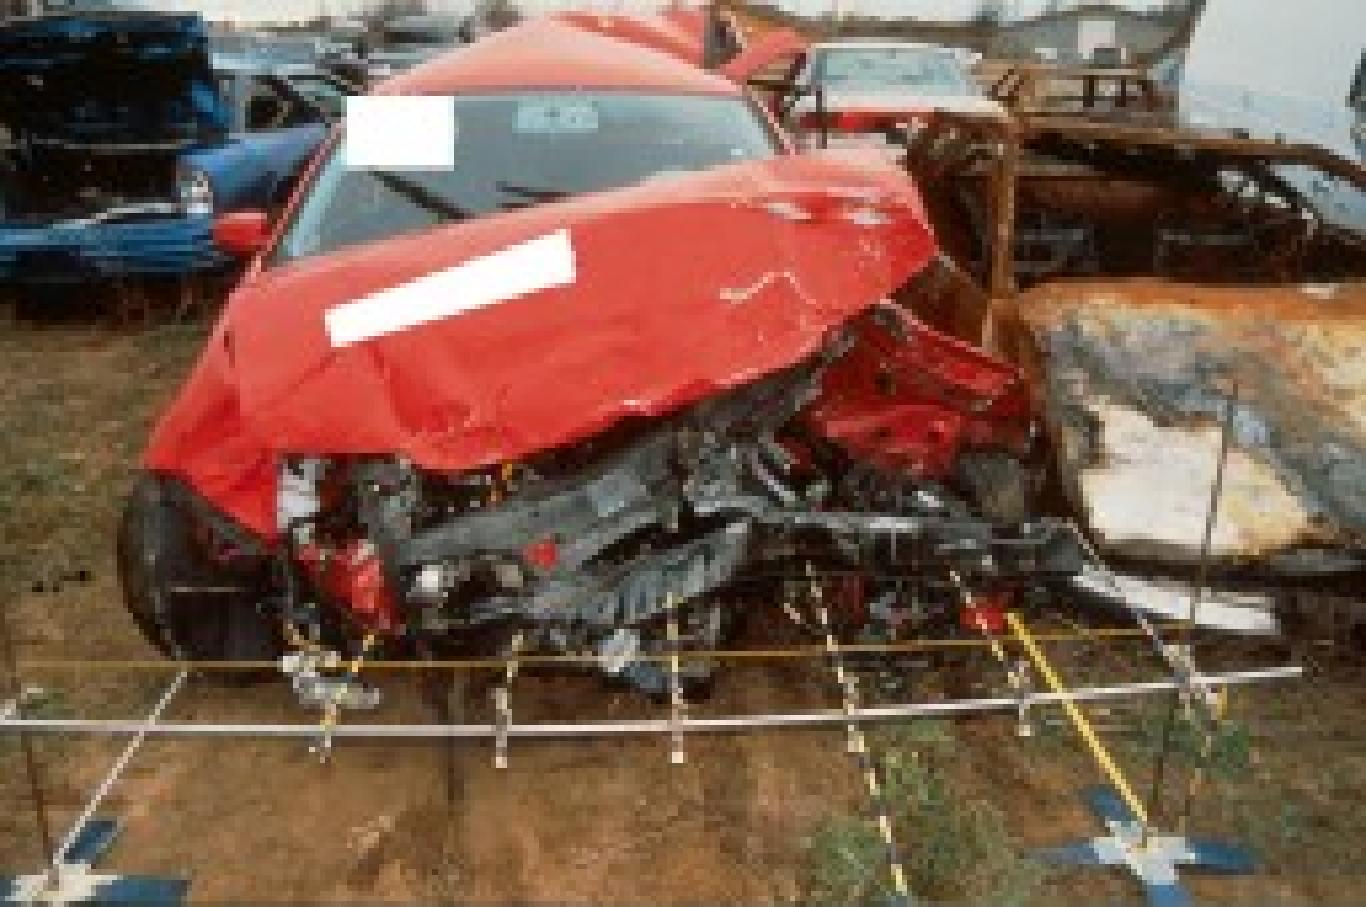
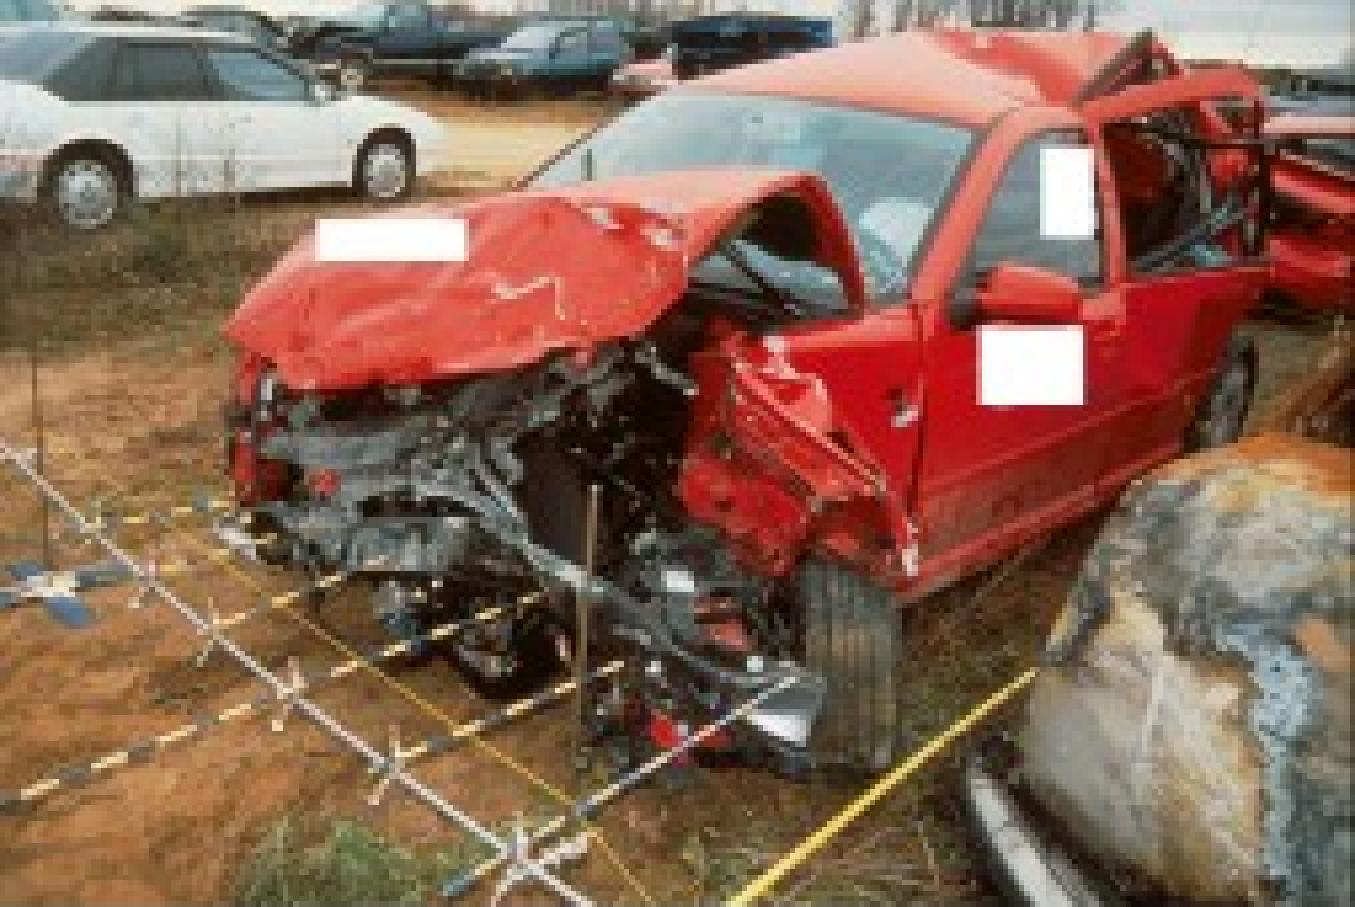
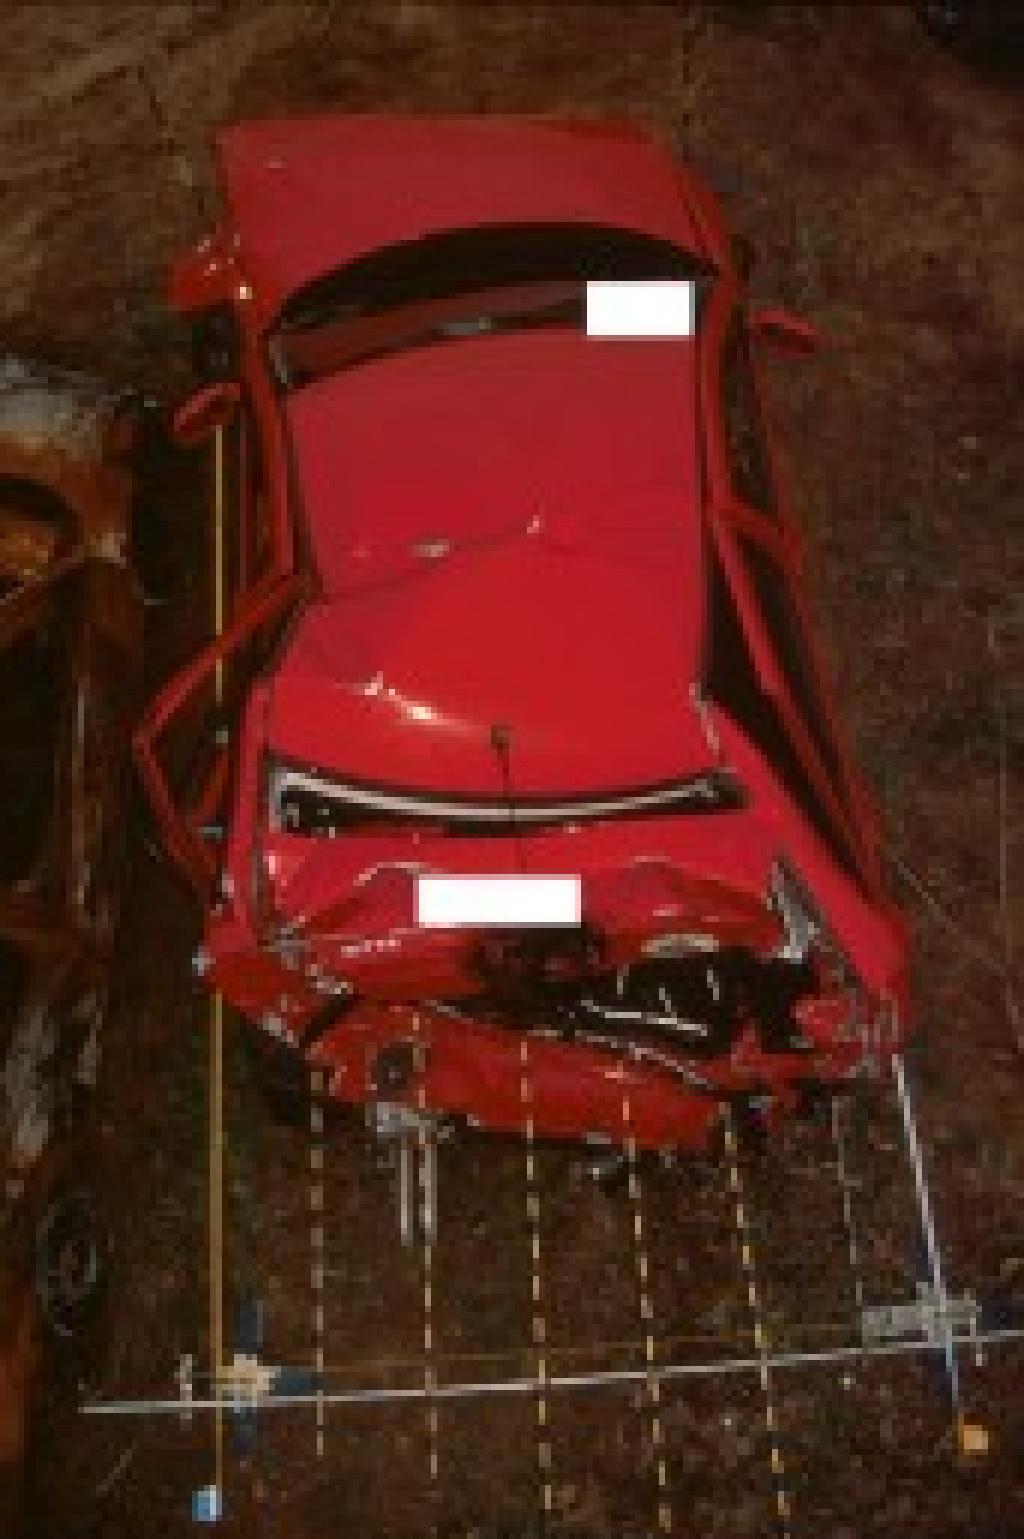
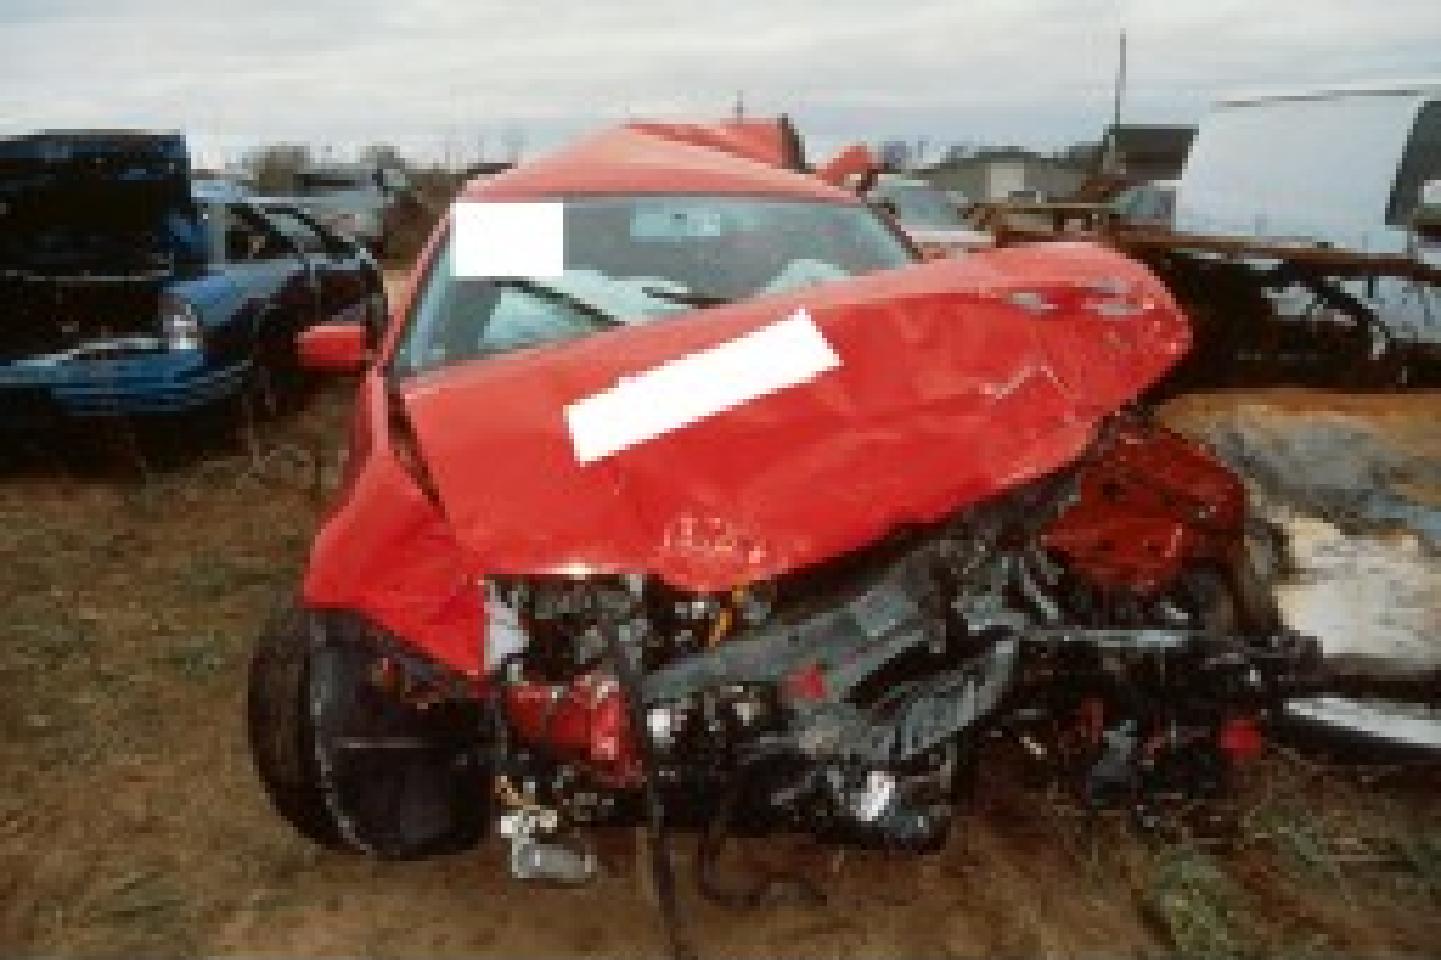
Using the WinSMASH accident-reconstruction program and (slides 4, 5, 6, 7, 8) c-values for case vehicle (A), the following impact severities were calculated:

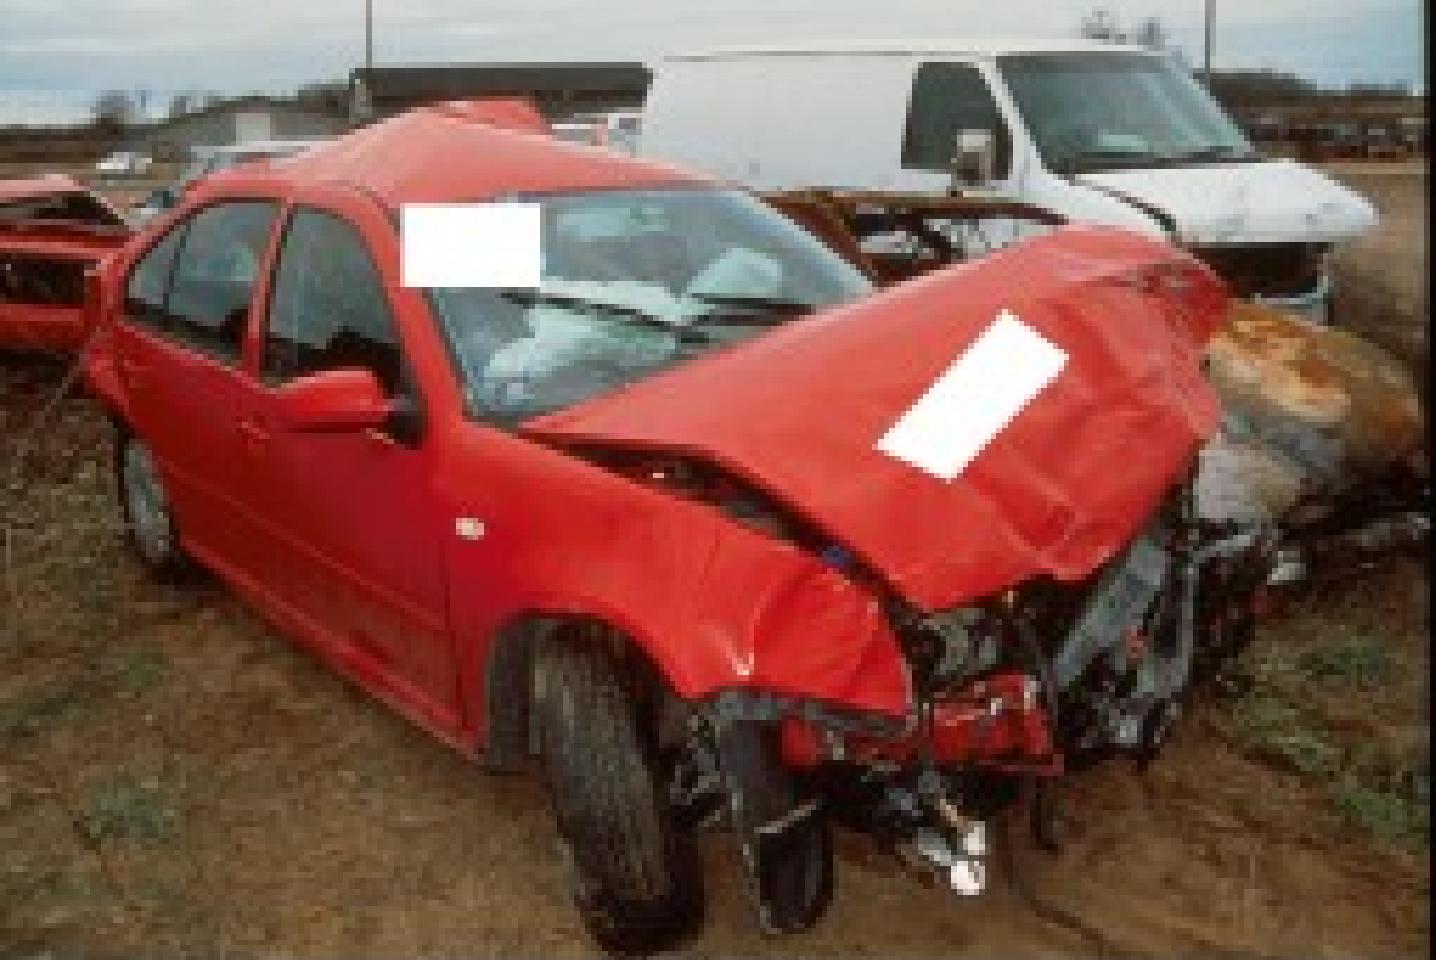
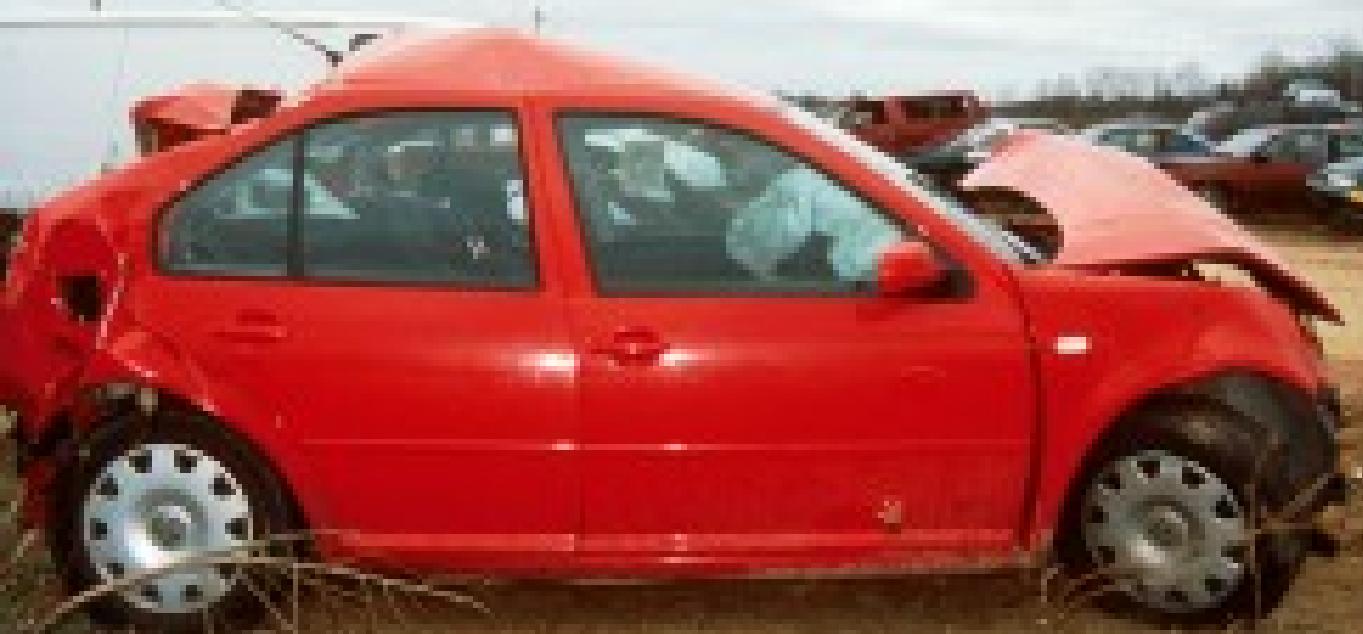
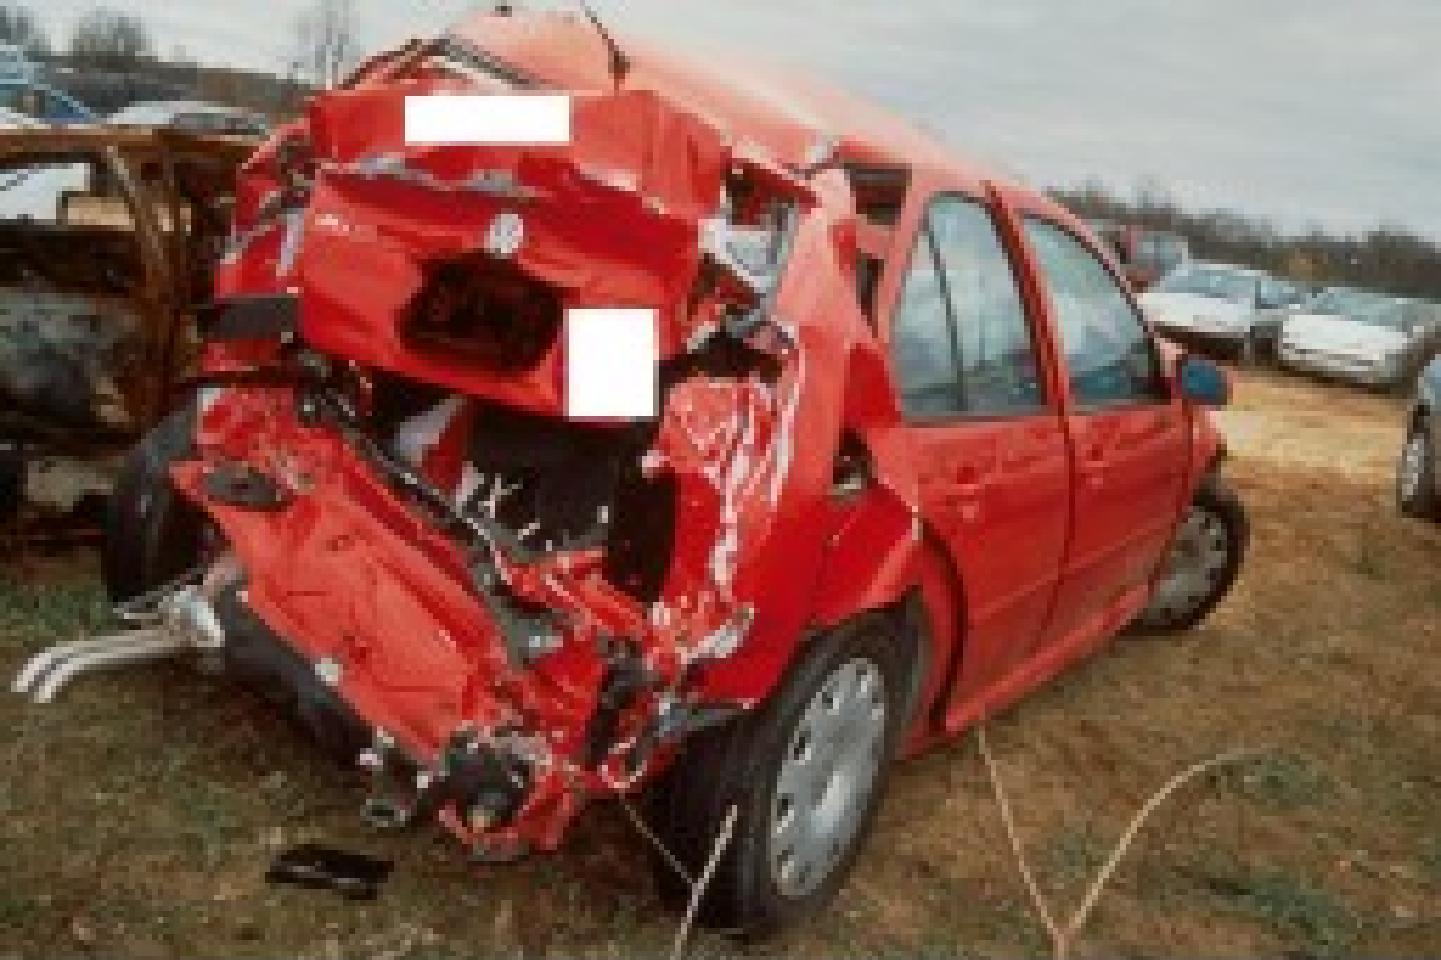
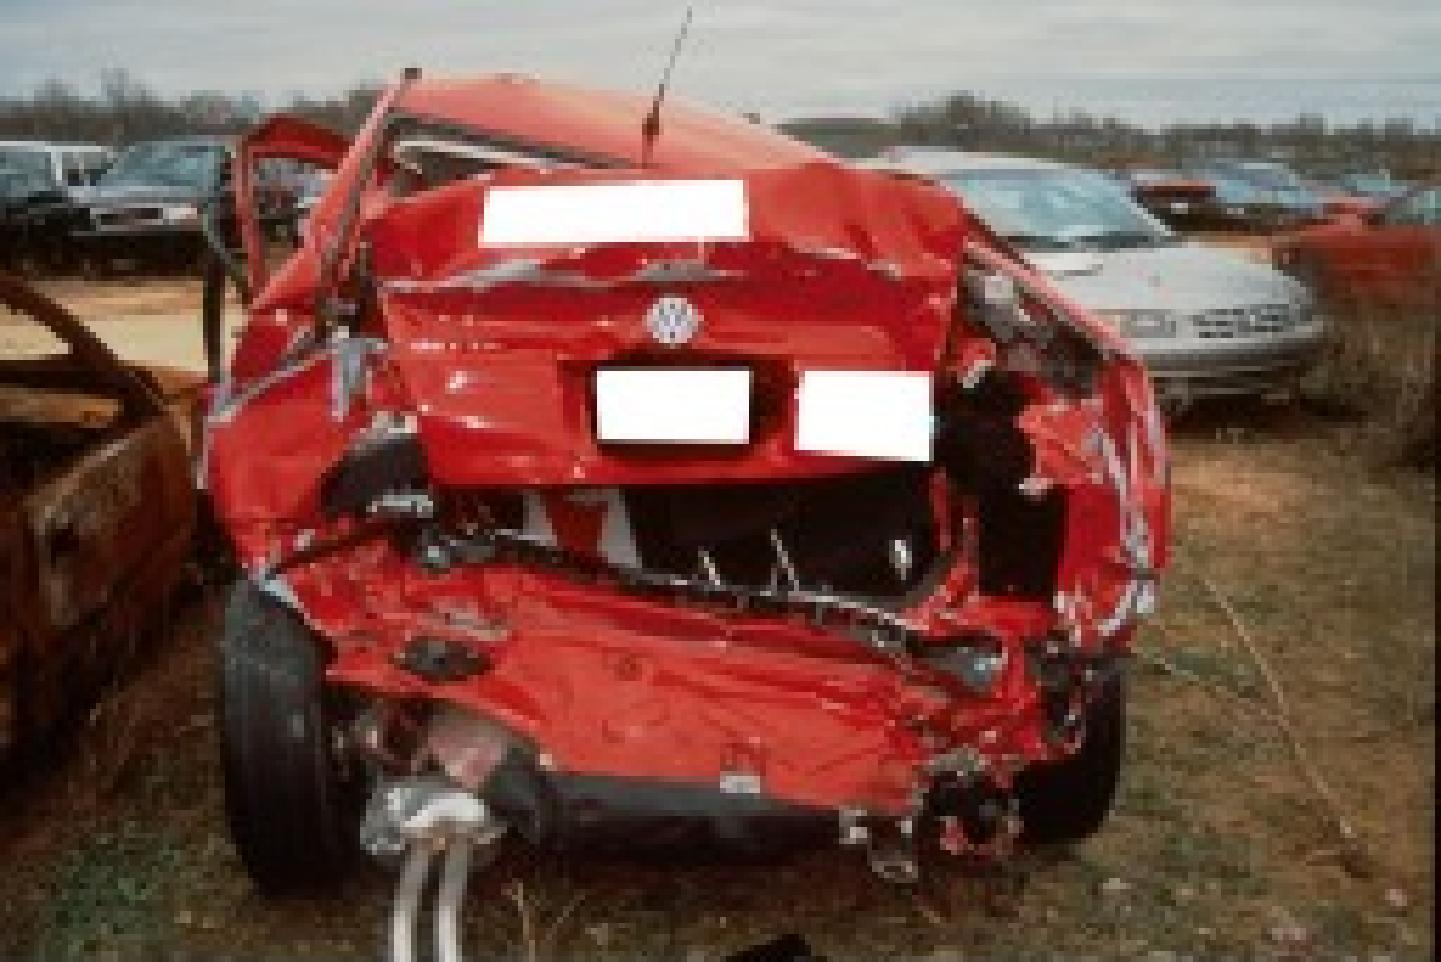
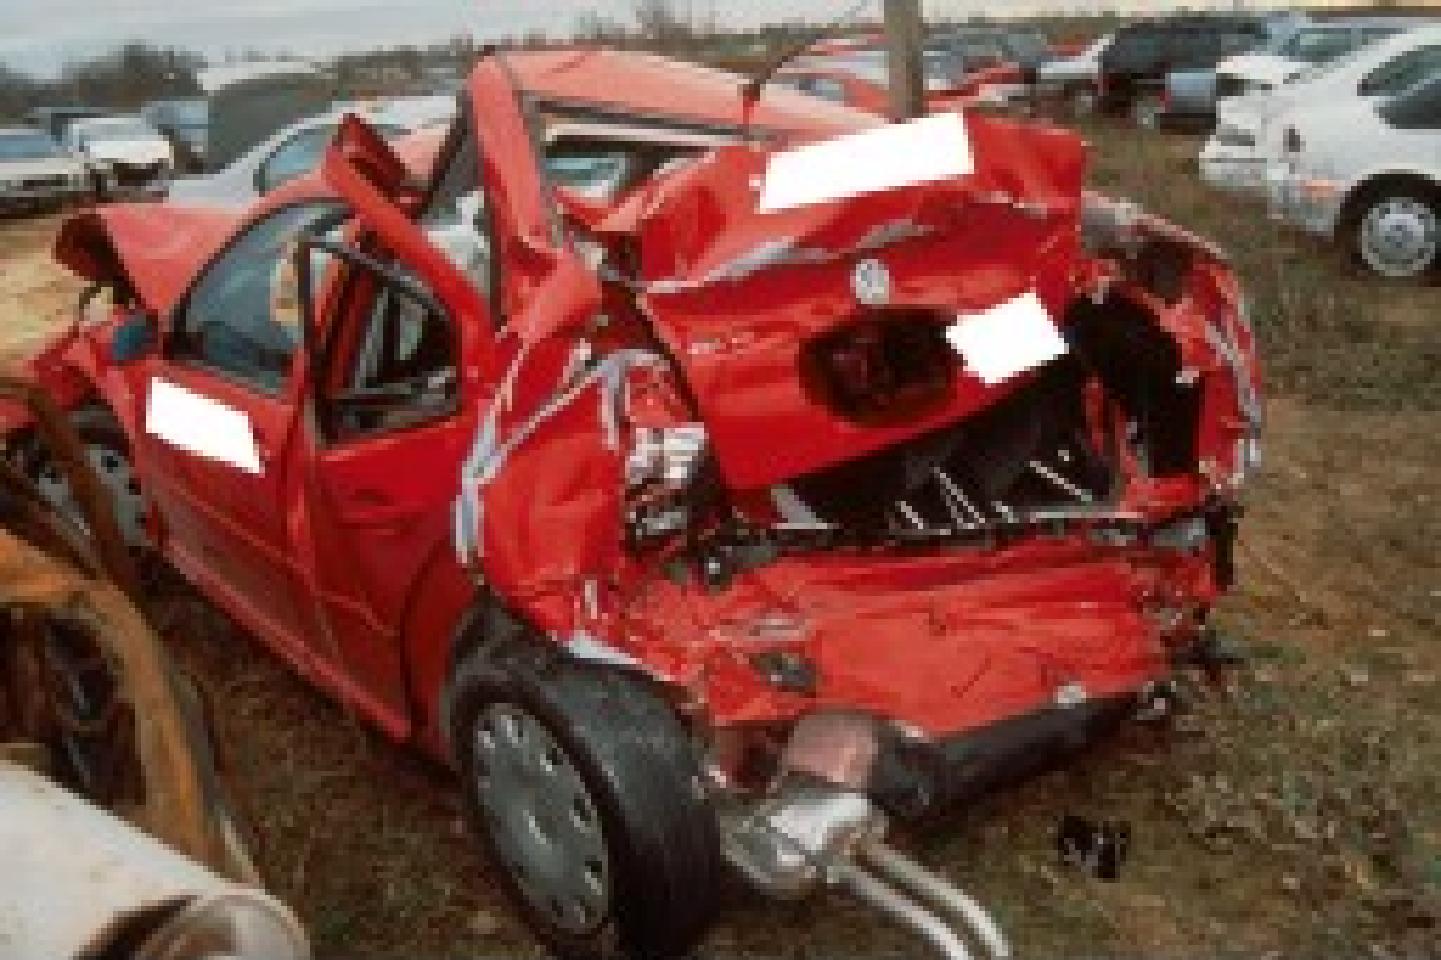
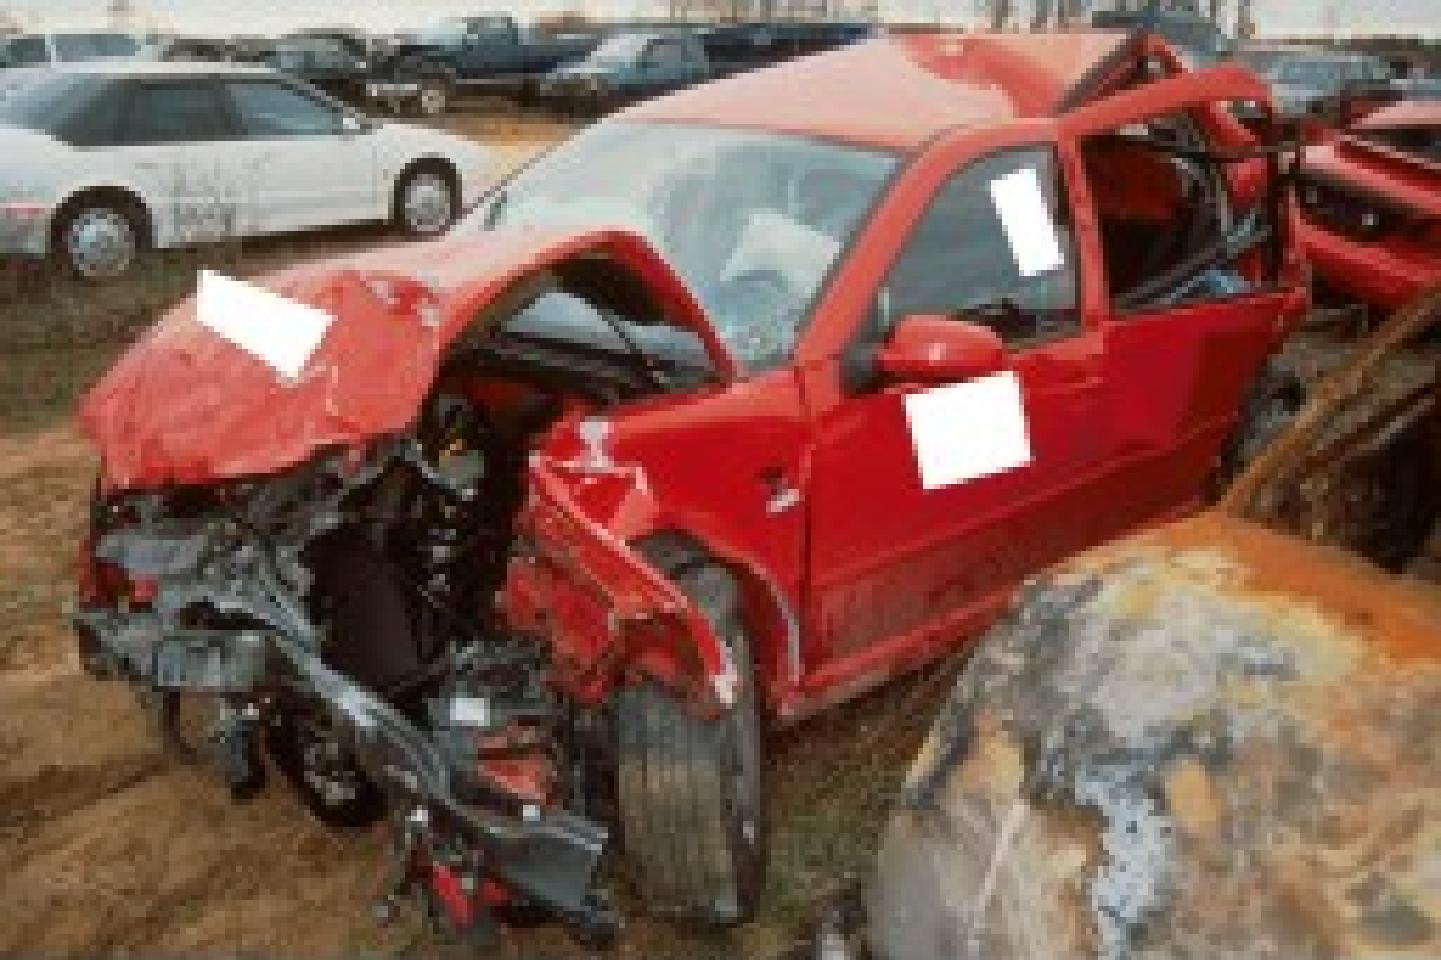
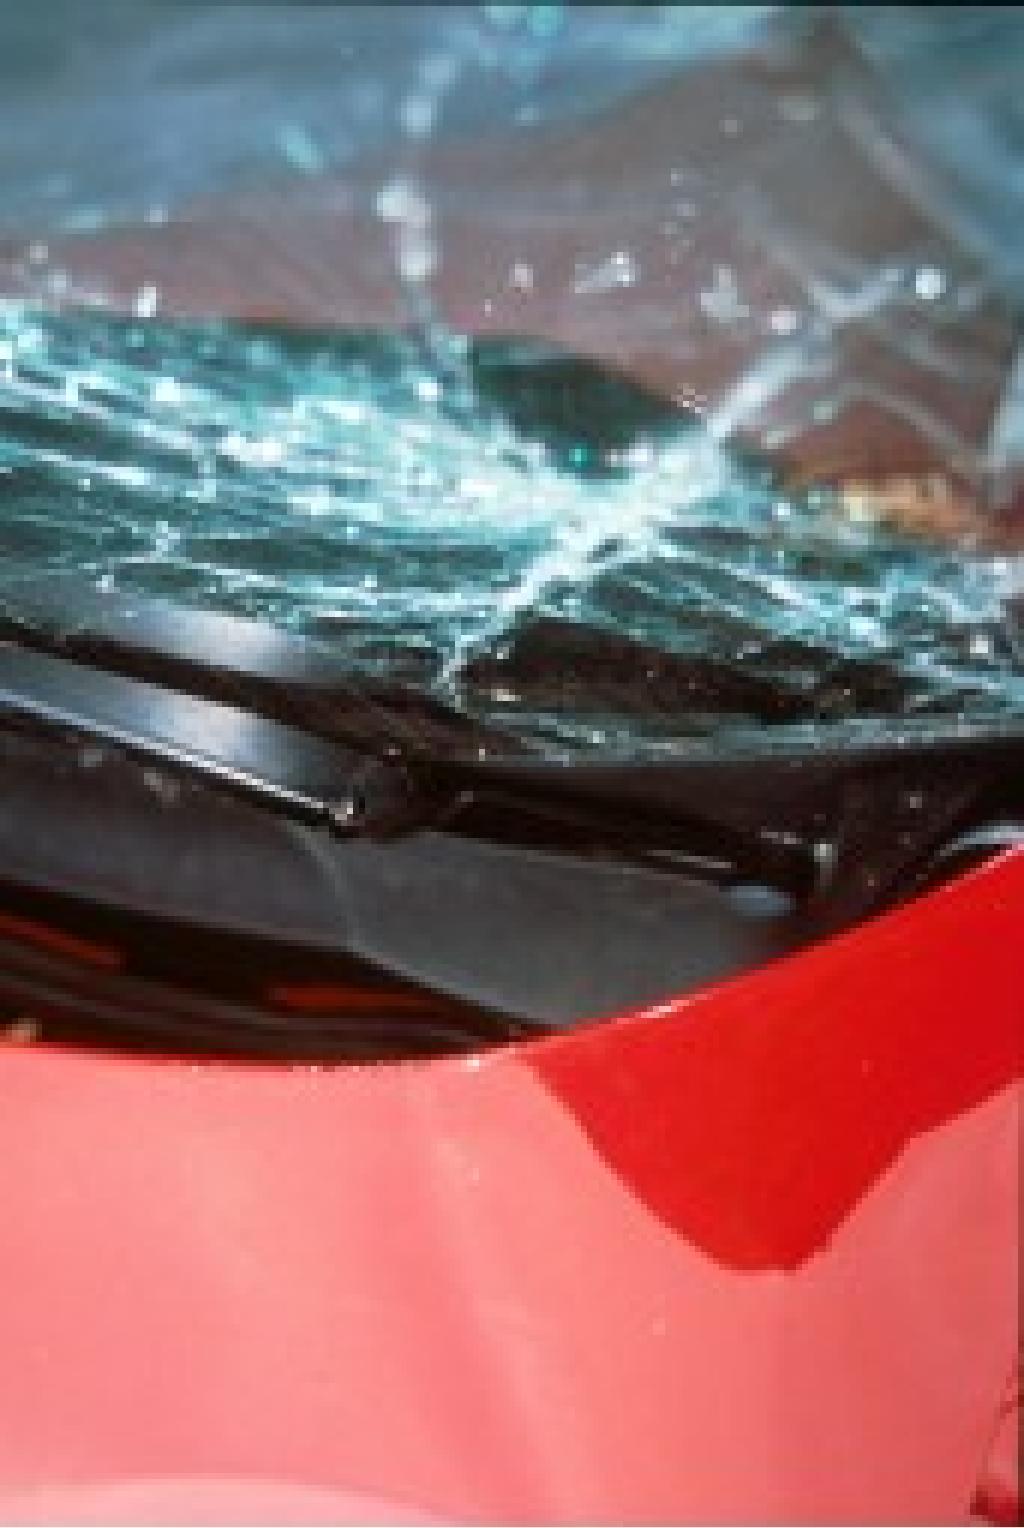
(Slides 9, 10, 11, 12, 13, 14, 15) The front bumper, both headlight assemblies, the grille, and the radiator were severely crushed from the impact with vehicle (B). (Slide 16) The hood was crushed and elevated and contacted the windshield, but did not penetrate it. (Slides 17, 18) The hood latch was damaged and released. Both hood hinges were damaged. The windshield was cracked by the stress of impact forces. The right fender was buckled and the left fender was severely buckled. Both front doors remained closed and operational. Both rear doors were jammed shut. All of the wheel struts were damaged. Both quarter-panels were severely buckled. The roof was buckled and the left upper A-pillar was deformed, as a result of the deformation of both of the C-pillars and both rear roof siderails. The back bumper, both taillight assemblies and the trunk lid were severely crushed from the rear impact by vehicle (C).
